Construction, Use, and Abandonment of a Thule Whale Bone House, Somerset Island, Arctic Canada

Junko Habu* and James M. Savelle*

In 1991, the authors excavated a Thule (ca. A. D. 1000-1600) whale bone house on Somerset Island, Arctic Canada. Several characteristics of the house structure and the associated artifact assemblage indicate that this house probably functioned as a *karigi*, or ceremonial house. It is argued that detailed analyses of house stratigraphy provide useful data for the study of formation processes of the house. Based on our analyses, five stages are recognized: 1) house construction, 2) house use and maintenance, 3) house abandonment, 4) dismantling of superstructure, and 5) post-occupation. It is also argued that such analyses can be extremely beneficial in understanding the nature of associated artifacts.

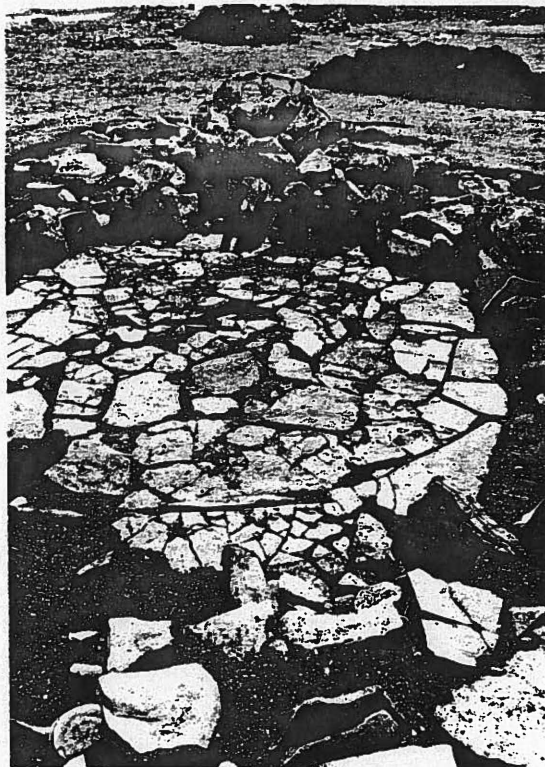
Fig. 4 Field photograph of House 5 flagstone floor; view southeast

We began our excavation in the centre part of the house. It soon became apparent that the house had a neatly flagged floor of flat limestone and dolomite slabs (Figure 4), but no apparent sleeping platforms. The flagstones were removed after mapping and/or photographing, and the entire flagged area was excavated to a basal sterile layer (layer 12 in Figure 7). The remainder of the house interior was excavated out to the sod wall (layers 9a and 9b) or a grease, baleen and skin layer (layer 10) which lay directly on and adjacent to the flagstones at the edge of the house interior. In addition, all trench units were excavated to the basal sterile layer. The interior of the entrance was excavated to the bottom of the entrance "well" (depressed floor in entrance) with

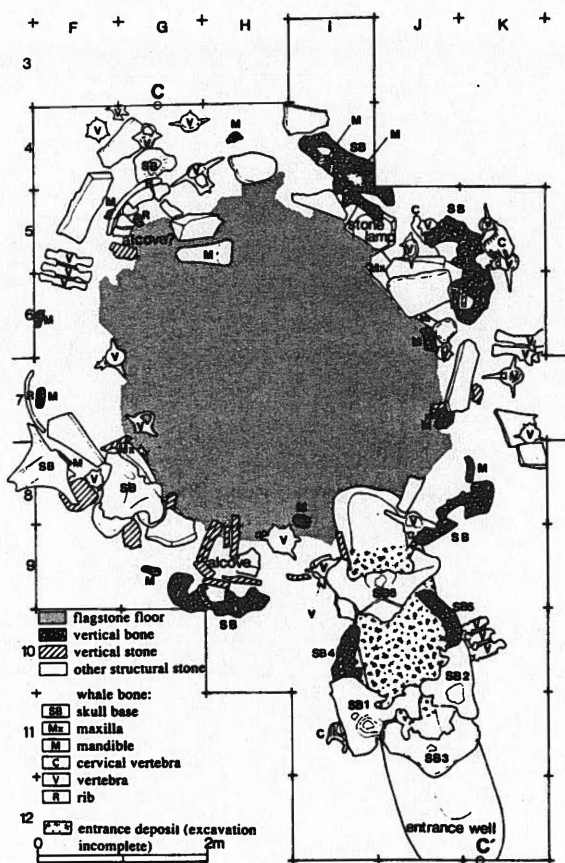
Fig. 6 House plan showing principal structural supports

The distribution of all structural whale bones and stones in the excavated area is shown in Figure 5, while only those interpreted as primary *in situ* structural elements are shown in Figure 6. Profiles and cross-sections are shown in Figure 7.

Most of the primary *in situ* structural whale bones and stones are arranged in a roughly circular pattern inside the house adjacent to the sod wall (layers 9a and 9b). Many of these were placed at floor level and embedded in layer 10, a thin layer of grease, baleen and skin just above the flagstone floor. Adjacent to, or placed on top of

The entrance consisted of a primary framework of six whale crania (SB1-SB6 in Figure 6) over an entrance "well". These six whale crania appeared to be *in situ*, since SB3 was firmly supported by several large stones (Figure 9), thus resulting in an essentially vertical exit. The entrance "well" measures 4.7×1.2 m, and was depressed at least 50 cm below the house floor level and 35 cm below the contemporaneous ground level (profile C-C' in Figure 7).

the exception of units I/J9-10 (see entrance deposit [excavation incomplete] in Figures 6 and 7). Time constraints and permafrost prevented the complete excavation of these latter units. The midden, which extends to the southeast of the entrance, was only partially excavated and its total extent is unknown.

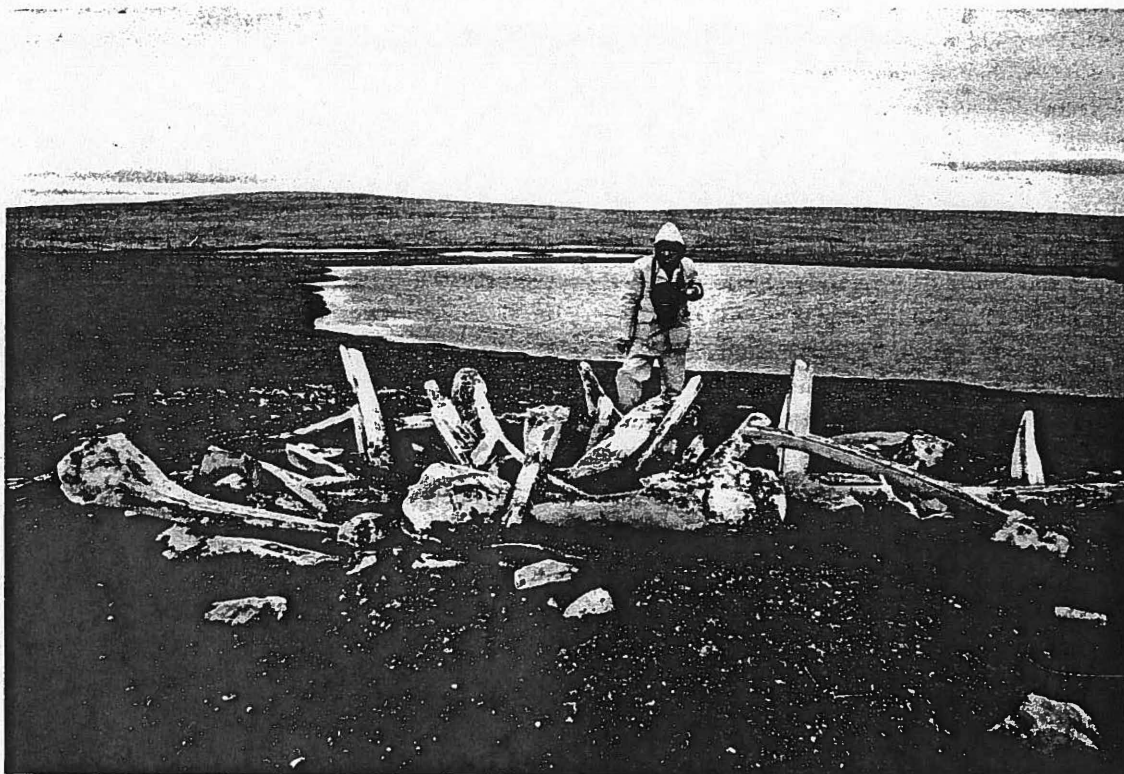
Fig. 12 Naturally collapsed whale bone house at the Debliquy Thule site, southeast Bathurst Island

As noted by McCartney (1979a), Canadian Arctic whale bone houses rarely escaped human-related post-abandonment disturbance, and House 5 is no exception. If House 5 had not been disturbed by humans after abandonment, we would have expected it to resemble the Izembak Lagoon, Alaska feature illustrated by McCartney (1979a, p. 317), or the house at the Deblicquy site (Taylor and McGhee, 1981) illustrated in Figure 12. In

both of these cases, the centre of the house has collapsed, resulting in a spoke-wheel arrangement of bones and a fill of smaller structural bone cross-pieces, sod, and stone slabs. This pattern is absent from House 5. Instead, the house seems to have been intentionally dismantled for whale bone and other architectural materials, such as stone benches. This process involved, first, the removal of the uppermost roofing materials (sod and stone slabs). We infer this from the lack of these roofing materials within the remains of the house structure. Many sod and stone slabs which are found on the east and north side of the house in the upper part of layer 3 may well represent the dismantled roof remnants.
